Service Bulletin

Subject: Lamp Adjust Spring

Product Line: Studio Command

Date: 10/06/06

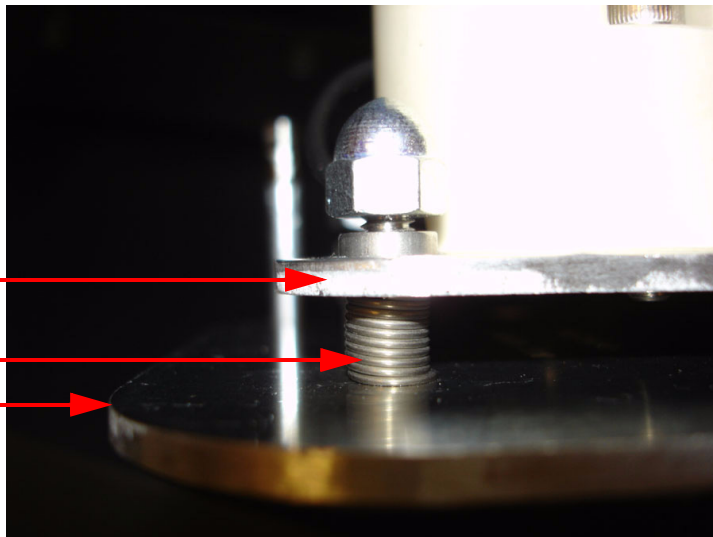
Lamp Adjust Assembly

The Studio Command lamp adjust assembly utilizes three (3) springs for adjustment between the "Outer Access Plate" and the "Lamp Socket Plate."

A limited number of fixtures were manufactured using adjustment springs that were too short, causing the optimizing plate to be in the wrong location, and making it impossible to properly optimize the lamp output.

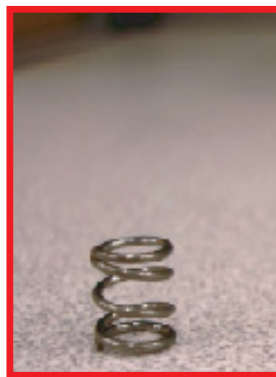
The wrong spring has four (4) winds to its coil.

Wrong
(Four wind Coil)

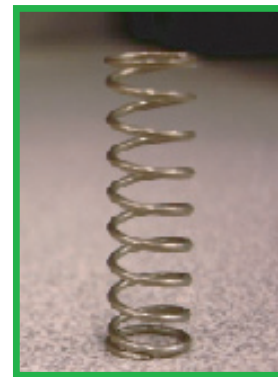
The correct spring has nine (9) winds to its coil.

Correct
(Nine wind Coil)
