# Flying Pig Systems

## Wholehog II MIDI Input Hardware implementation error & modification

Serial numbers affected: ALL CONSOLES UPTO 05160

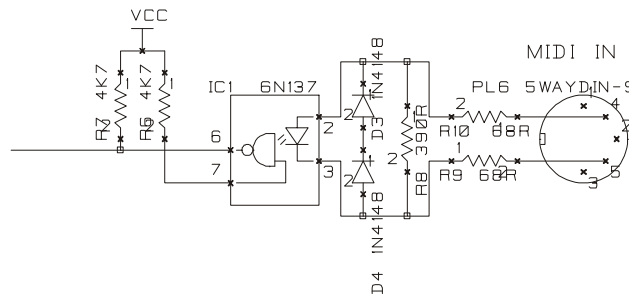
There exists a hardware error in the Wholehog II MIDI Input implementation. Referring to Figure 1 it can be seen that a resistor, R8, exists across the MIDI input signal lines. This resistor should not be there and may cause MIDI receive data errors or no reception at all.

To ensure correct operation this resistor must be removed. Please consult Figure 2 to locate its position on the back panel (I/O) pcb. It is recommended that the resistor simply be cut out without removing the circuit board taking care to ensure that the console is disconnected from the mains supply. It would also be most helpful if you could notify me via email (below) of the serial numbers of any consoles thus modified. Thanks.
