Flying Pig Systems

Wholehog II timecode (SMPTE) input Hardware implementation & recommendations

Serial numbers affected: ALL CONSOLES UPTO 04170

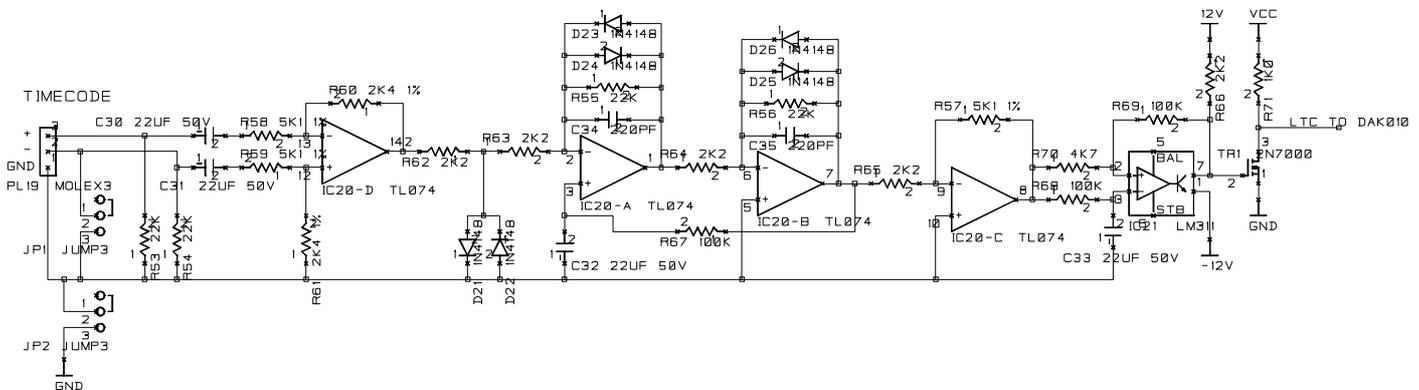
Figure 1

The Wholehog II is designed to accept a balanced timecode signal ranging from -20dB to 0dB in level and the input stage is given for reference in figure 1.

As you can see from figure 1, my response to this was to incorporate a ground lift jumper (JP2) for which the default factory setting was lifted. This rather clumsy method of isolation is highly unsatisfactory as the ground voltages may now be allowed to vary enough to cause unreliable signal detection at the gate of TR1. Indeed, large potential differences may and do actually damage this and certain other components.
