SHOWGUN

Potential ballast failure due to voltage holdover

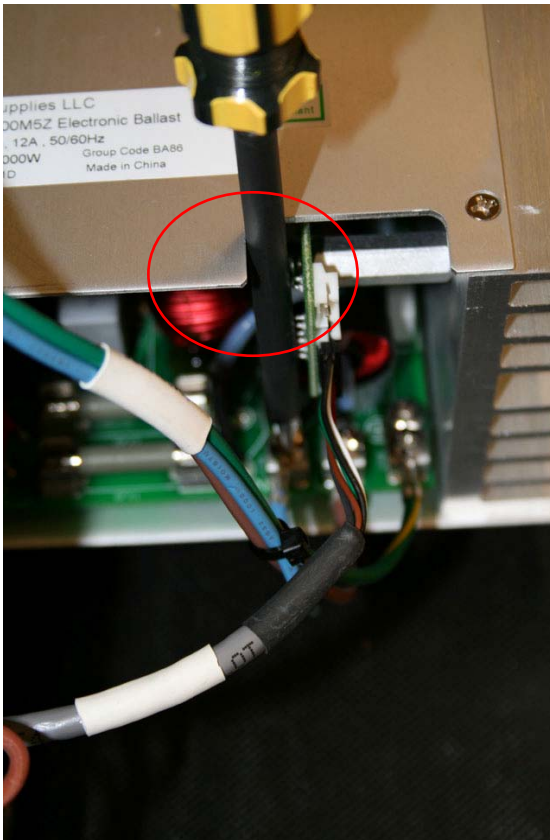
It has been observed that due to the very long voltage holdover of the ballast, using a non insulated screwdriver can cause a short that can cause damage to the lamp enable circuit.

To prevent this failure, always use an insulated screwdriver. Proper screwdrivers will have the following ratings, VDE approved handles, insulated to 1,000 Volts or certified to IEC 60900:2004. If an insulated screwdriver is unavailable, install heat shrink tubing over the screwdriver shank.
